## **Lead Based Paint Dust Wipe Analysis Dust Hazard Mitigation Plan and Lead Inspection Report Risk Assessment (preliminary phase)**

**195 McGregor Street,  
Manchester, NH 03102**

**Residential Report**

**American Environmental Testing Services, LLC  
1 Hardy Road, Suite #218 Bedford, NH 03110**

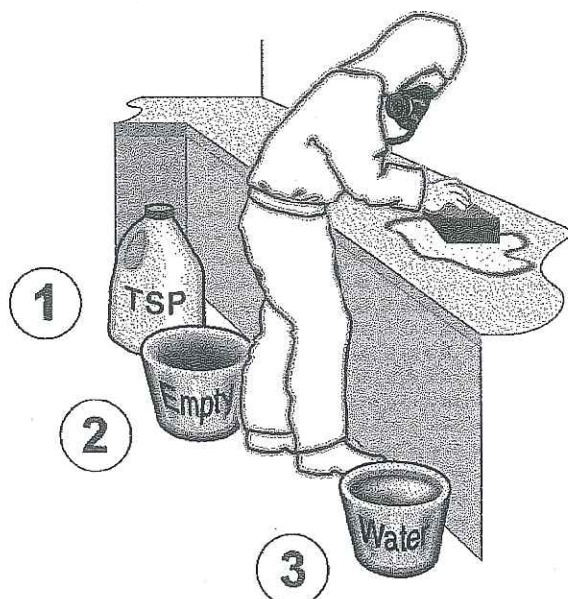
**Wash all surfaces with suitable detergents**

Wash *all surfaces* in the work area with suitable detergents, including areas that had been covered with plastic. Some wallpaper should only be HEPA vacuumed, since it may be damaged by the detergent.
